# TECHNICALLY Speaking

Article No.: TASC-TIP-01-09

## AW55-50SN Join the Club

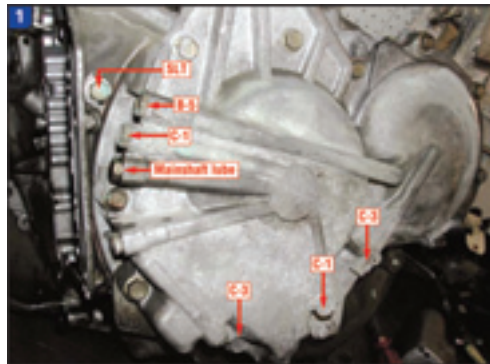
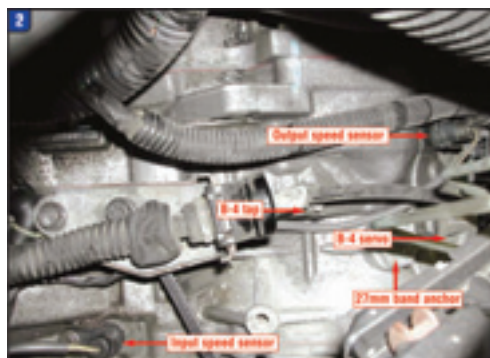
This transmission has pressure ports available for all circuits (see Figures 1 & 2).

If the unit is still in the vehicle, start with a good set of gauges or preferably transducers, at the B-4 servo port and compare it to the C-1 clutch. These pressures should be the same in 3rd, or not vary more than 10 PSI. If B-4 is lower than C-1, it is possible the servo feed tube o-rings are leaking. If C-1 is lower, you have a problem, because C-1 is the input clutch and pressure fluctuations create delayed engagement and flare shifts.

Next step is to move from the C-1 port to the B-5 clutch port. Monitor the time it requires for the B-5 to release and B-4 to apply. Do you have a prolonged low or -0- gauge reading? If so, that is a valve body or solenoid control problem.

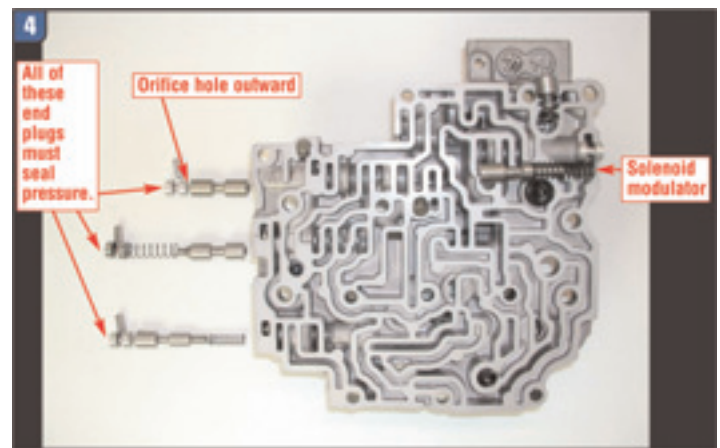
The most overlooked bore related to our complaint, is the B-4 release near the spring spool area (see Figure 3a). It may appear as if you can buff out the ridge wear, but with the existence of a cross leak, the valve is almost certain to hang up.

In some applications the B-5 control valve has a return spring (see Figure 3b). The existence or absence of a spring corresponds to a specific separator plate and TCM calibration.

Line rise is critical on this unit. As you inspect these castings, you will find wear at many of the SLT linear solenoid junctions. Last but not least, the fluid source that feeds all the linear solenoids, the solenoid modulator bore, is one that is commonly worn and always deserves careful inspection (see Figure 4).

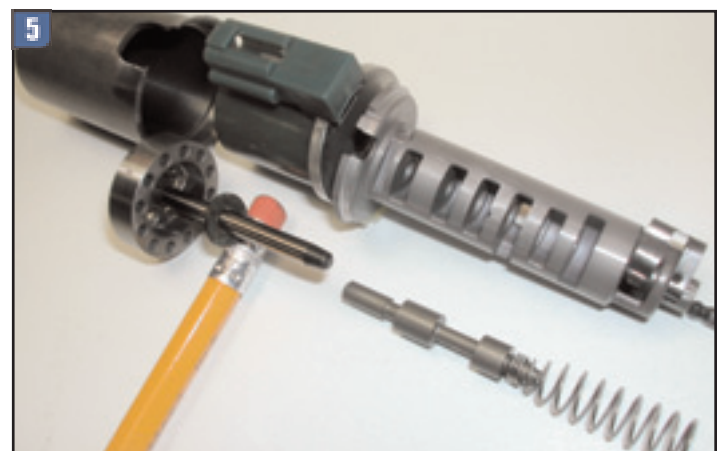
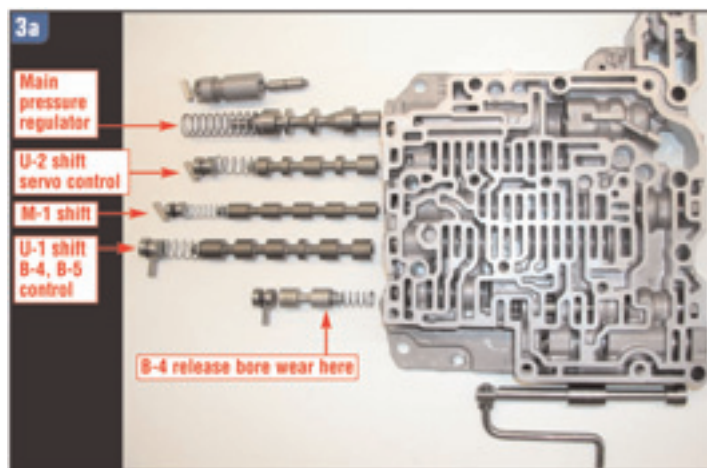
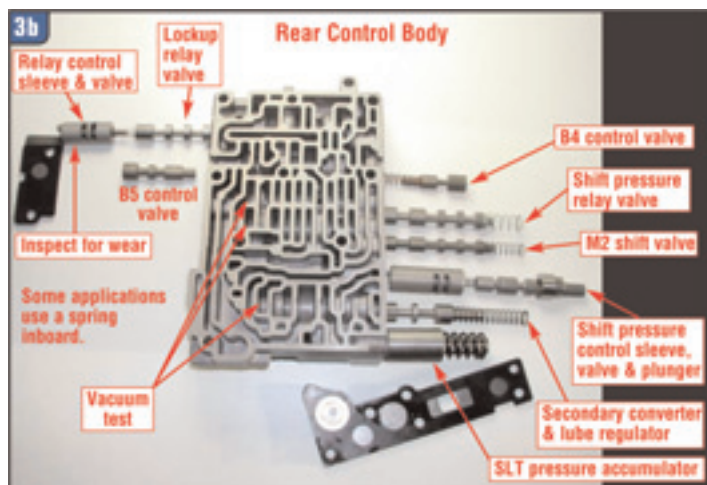
The linear solenoids (SLU, SLS & SLT) modulate the clutch pressure, and the on/off solenoids control the path the fluid takes. Problems with the linear solenoids include contamination, spring sag, and wear, and they have a critical adjustment procedure. Figure 5 is an exploded view of a linear solenoid. The two solenoids we focus on for this material are the SLT and SLS. The SLS is pulsed on each shift to interrupt the clutch pressure and the SLT ramps the clutch and line pressure to match engine load.

As mentioned earlier the solenoid modulator valve feeds all the linear solenoids. You can compare its function and related concerns to the GM actuator feed limit valve. Wear reduces pressure to the solenoids so they are slow to react, but wear also reduces the maximum output. The solenoid modulator can be tested at the SLT port. At maximum line, SLT should not exceed 90 psi.

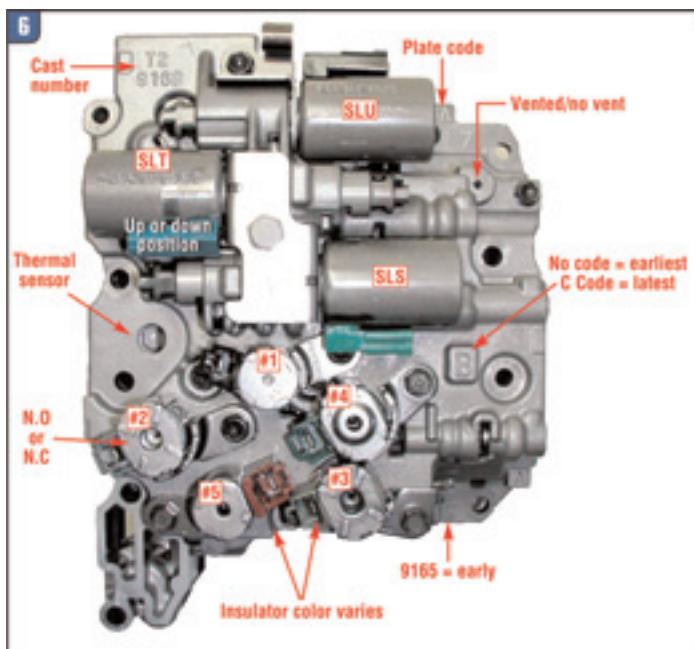
On/off shift solenoids must be able to flow more than their feed orifices supply when open. Restricted solenoids or leaking solenoids position a valve mid-way. To flow properly it must snap in or out quickly. The solenoids are fed from line pressure orifices within the top cover plate. Be careful as the #2 solenoid varies by application and can be either a Normally Open or a Normally Closed solenoid. It is also easy to mix the connectors between the S1 and S3 (Figure 6).
